PROVIN MOUNTAIN RESERVOIR

MA 00528

PHASE I INSPECTION REPORT NATIONAL DAM INSPECTION PROGRAM

JUNE 1981

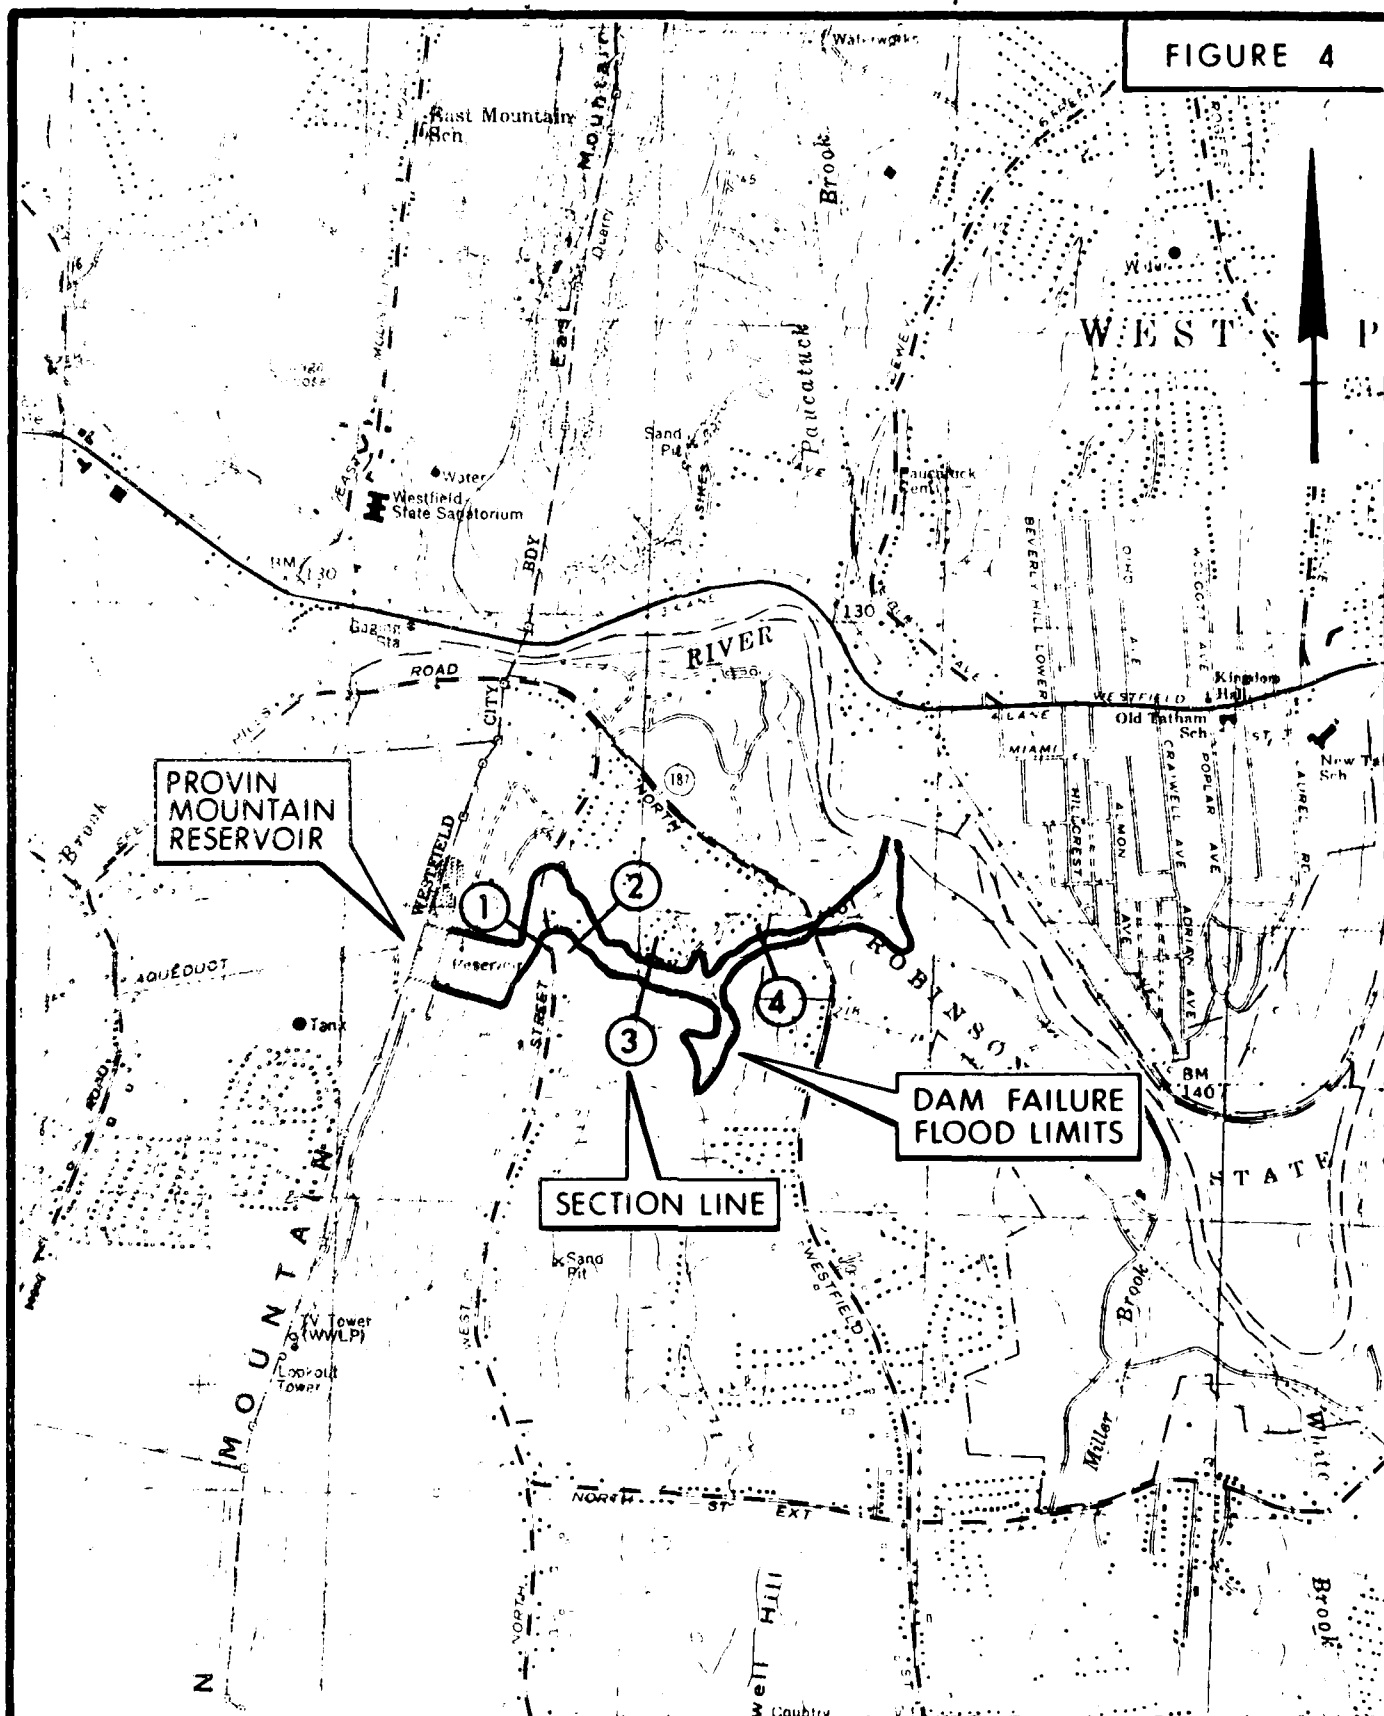
FIGURE 4

DAM FAILURE FLOOD LIMITS

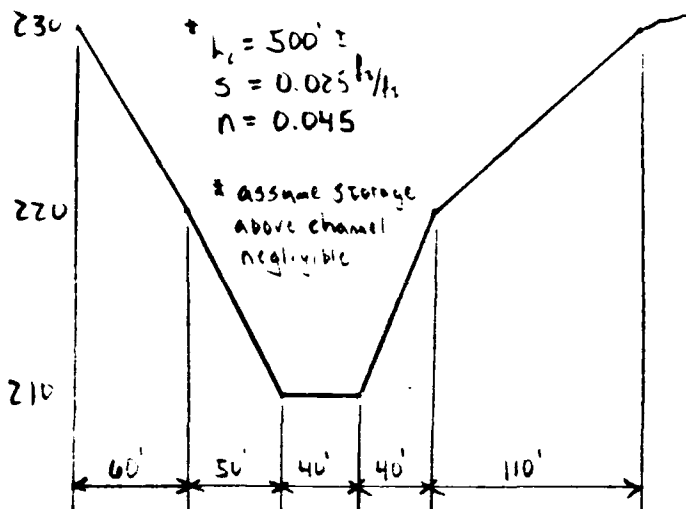
① Section 1200' ± downstream of reservoir (from ASGS) $\frac{1''}{1'}$ = 100' Horiz. $\frac{1''}{1'}$ = 10' Vert.

Following the rupture of the tanks, the failure outflow would travel eastward down the mountain as sheet flow, most likely inundating and doing severe damage to the access road and two buildings, for approximately 800 ft. before reaching a stream channel flowing north.

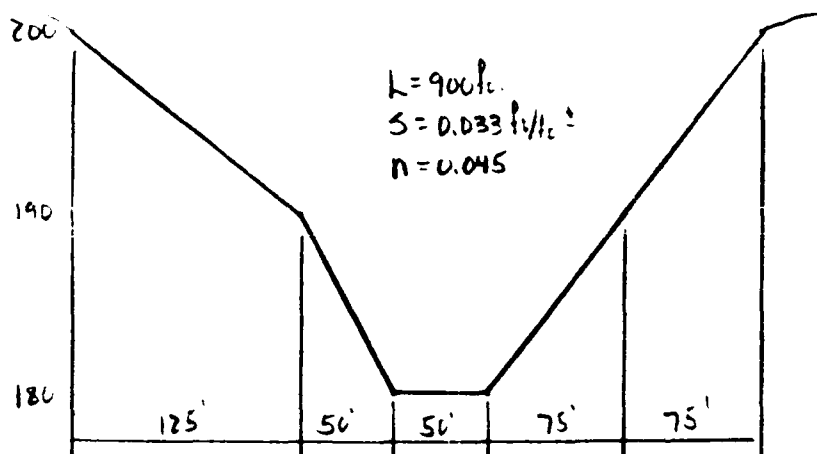
③ Section 2100' \pm downstream of reservoir (from USB) $\begin{matrix} P = 100' \text{ H.A.} \\ P = 10' \text{ V.H.} \end{matrix}$
 NOTE: Roadway will be overtopped. Assume no influence on flow

Assuming a constant water surface slope between the first two sections, the roadway (North West Sec.) would be overtopped by 8 to 9 ft \pm and at least 2 buildings in a residential area would be damaged.

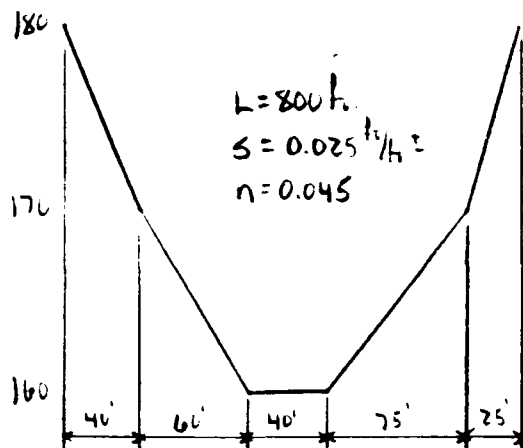
③ Section 2900 ft. downstream of reservoir (from USGS) $\frac{1''=100' \text{ H.}}{1''=10' \text{ V.}}$

③ $Q_{P_3} = 41,173 \text{ cfs}$

$H = 13.8 \text{ ft.} \pm (E1.173.8 \pm)$

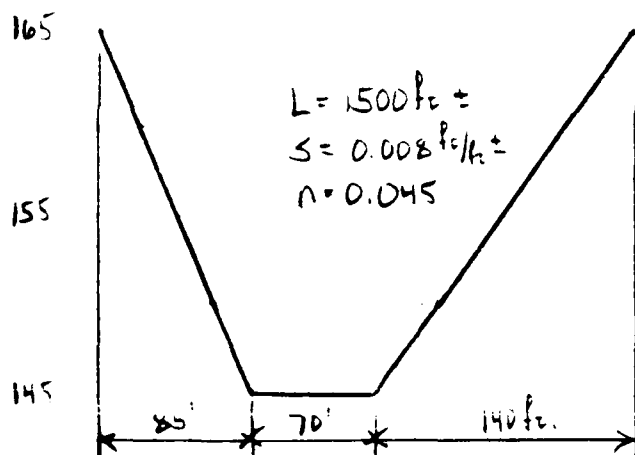
- ④ Section 4400 ft. \pm downstream of reservoir (from 4565) $\begin{matrix} 1'' = 100' \text{ HORIZ.} \\ 1'' = 10' \text{ VERT.} \end{matrix}$
 NOTE: Base flow in channel neglected since peak failure outflow is not directly related to rainfall

At this elevation, North Westfield S. would be overtopped by 4 to 5 ft. due to the peak failure outflow. Approximately 2000 ft. downstream of this section, the flow would be attenuated by Dr. Westfield River.
